IPC2006-10208

GEOHAZARD RISK MANAGEMENT FOR THE NOR ANDINO GAS PIPELINE

Michael Porter, BGC Engineering Inc.

Rodolfo Reale, Gasoducto Nor Andino

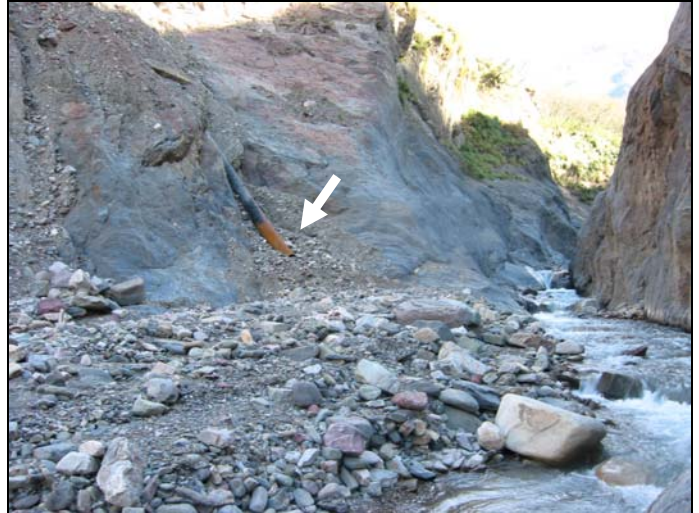
Figure 2. Looking Upstream at the Failed Crossing

In March 2001 a pipeline rupture occurred at a crossing of the San Andrés river, Argentina, near KP 97 (Figure 2). The crossing was located at the end of a 15 m wide gorge that extends upstream for about 300 m. The river drops about 50 m over this short section. At the terminus of the gorge there is a transition from bedrock walls to sand and gravel banks that have been incised about 20 m.

It is believed that the pipeline failure was caused by the breaching of a landslide dam that led to an outburst flood or high intensity debris flow. The first damage at the crossing likely entailed bank erosion caused by flooding, while the actual rupture of the pipeline was caused by the debris flow. The debris flow had a peak discharge of at least twice the calculated discharge for the 50-year water flood, consistent with observations by Jakob et al. (2004). Debris flow velocity was estimated at between 6 and 8 m/s. Debris densities were observed to exceed 1,500 kg/m³.

A temporary 6" bypass pipeline was constructed downstream and was operated until the damaged crossing could be repaired. The incident caused 25 days of business interruption.

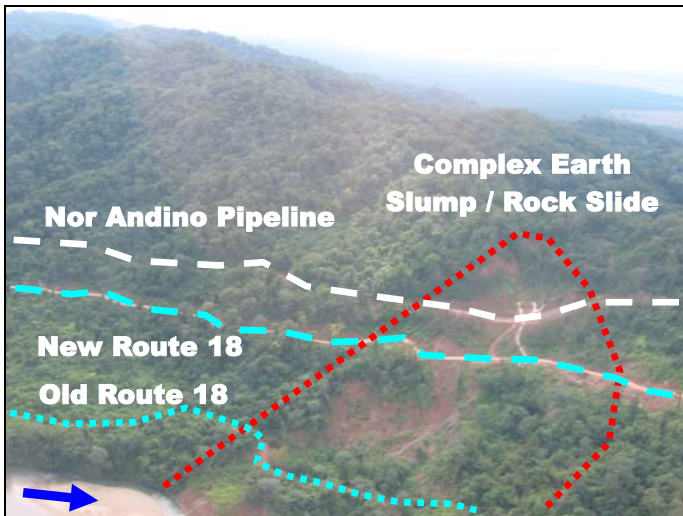
Figure 3. Slope Stability Issues near KP 40

Between KP 40 and 41, the pipeline descends a west-facing slope from the ridgeline to the valley bottom, running sub-parallel to the slope contours (Figure 3). The left bank of the Rio Blanco aggressively erodes the toe of this slope.

On January 27, 2002, a pipeline rupture occurred following several metres of slope deformation, later determined to be caused by a complex deep-seated earth slump and rock slide.

The crest of the rock slide escarpment was located 30 m above the RoW. At the RoW the slide experienced downward displacements varying between 5 and 15 m. In turn, the base of the slope was located at the level of the left margin of Rio Blanco. The slide displayed lateral displacements of approximately 20 m at the toe, which comprised thick colluvial soils that slumped into the river.

- increased pore pressure as a consequence of 200 mm of rainfall in less than 24 hours on the day prior to the incident;
- unfavorable geological conditions, including the presence of clay-rich rock strata oriented sub-parallel to the slope inclination; and,
- excavation for the new routing of Provincial Route No. 18, located immediately below the RoW.

As a consequence of this rupture, gas flow was interrupted for 90 days until a slope stability analysis was performed, the necessary emergency repair measures were determined, and repairs to the damaged pipe were completed. The pipeline was operated above ground for several months in order to reduce the potential transfer of loads to the pipe in case the slope continued to deform.
