## THE ROLE OF AERIAL PHOTOGRAPH INTERPRETATION IN NATURAL HAZARD AND RISK ASSESSMENT

**Selina Tribe, Ph.D., P.Geo.**  
Senior Geoscientist

**Mark Leir, P.Eng., P.Geo., LEG**  
Senior Engineering Geologist

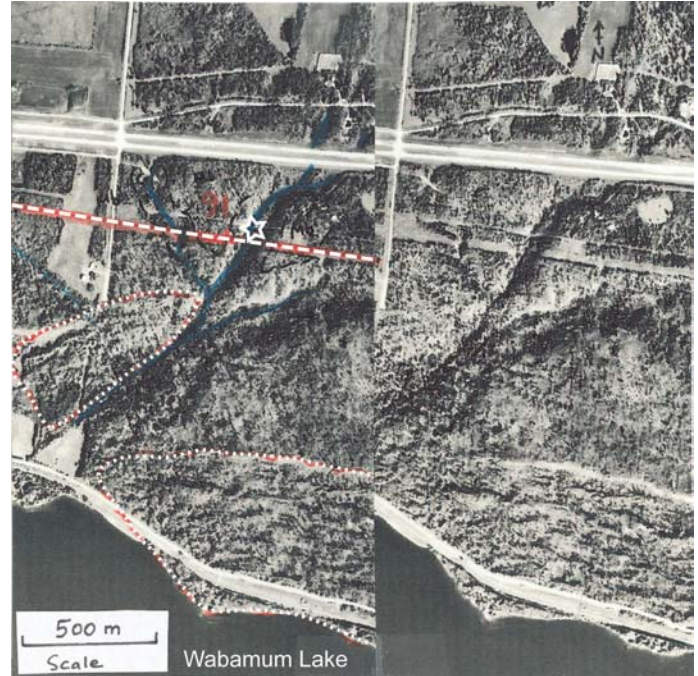
**Figure 2 Top: Stereogram of pipeline (dashed) near Wabamun Lake, 90 km east of Edmonton, Alberta, showing large areas of landsliding along the shore of the lake (dotted). Star shows location of Figure 3.**

Aerial photograph interpretation of the right-of-way is an integral step in building a complete geotechnical inventory [3,11]. Using photo interpretation, one can identify all hazards and conditions affecting the pipeline including those not visited or readily accessible in the field (Fig. 1), and those places where signs of instability are not evident on the ground (Figs. 2, 3). For example, landslides of probable early post-glacial age along the northern shore of Wabamum Lake, Alberta illustrate the potential for similar failures along the right-of-way that are not immediately visible during field inspection (Figs. 2, 3).

Aerial photograph interpretation is a powerful technique for assessing terrain conditions but it does have limitations. Chief among these is the fact that forest cover obscures details of terrain and may hide small landslides (Fig. 2). Additionally during Stage 1 and 2 studies, there may be insufficient resolution in small-scale aerial photographs to properly assess the effectiveness of various defences that may influence the exposure of a pipeline to a hazard. For example, berms, rip rap, and other modifications may be difficult to discern given the scale of most commonly available air photos. Their identification also will depend on river stage and degree of forest cover. If using aerial photographs of 1:15 000 scale or larger, these modifications can be discerned in most cases.

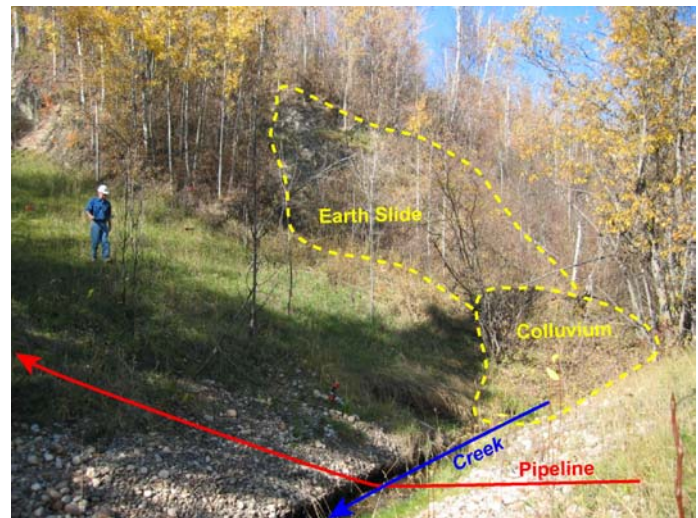
**Figure 3 A small earth slide was observed at the stream crossing at KP 91 (Fig. 2 star). No indication of the greater extent of landsliding visible on the aerial photographs.**

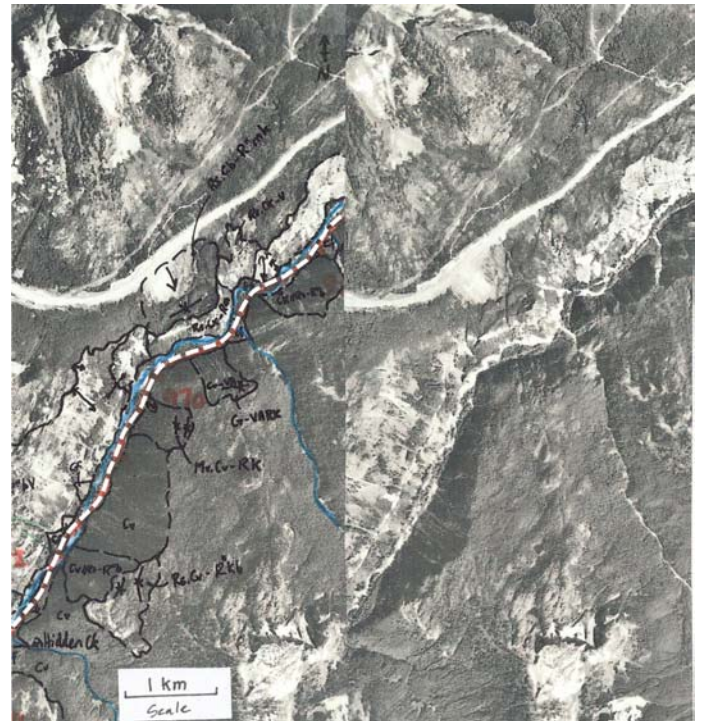
**Figure 4 Stereogram of a pipeline (dotted) along Coquihalla River canyon located northeast of Hope, B.C. In this region, the pipeline is exposed to a multitude of geo- and hydrotechnical hazards.**

Throughout British Columbia and in other glaciated areas of relief, pipelines located on river floodplains or the floor of river valleys (Fig. 4) are subject to greater hazard exposure than those located on benches or terraces (Fig. 5) above the valley floor, or those located on highlands and plateaus.

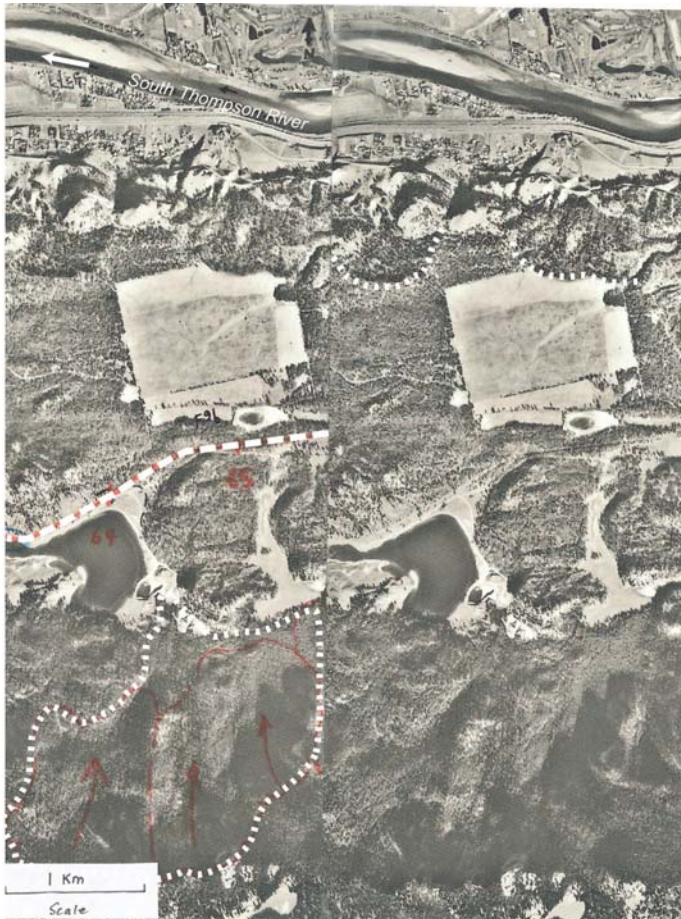
**Figure 5 Stereogram of a pipeline (red line) traversing a bench in the South Thompson River valley east of Kamloops, B.C. The pipeline follows a relatively hazard-free route that is set back from the influence of downslope headward erosion, and upslope rock fall.**
